BALLYRUSH
CS 10; IG 167

DOWN 10:49

ARCHAEOLOGICAL SURVEY OF NORTHERN IRELAND

BI-VALLATE
(TRI-VALLATE) RATH

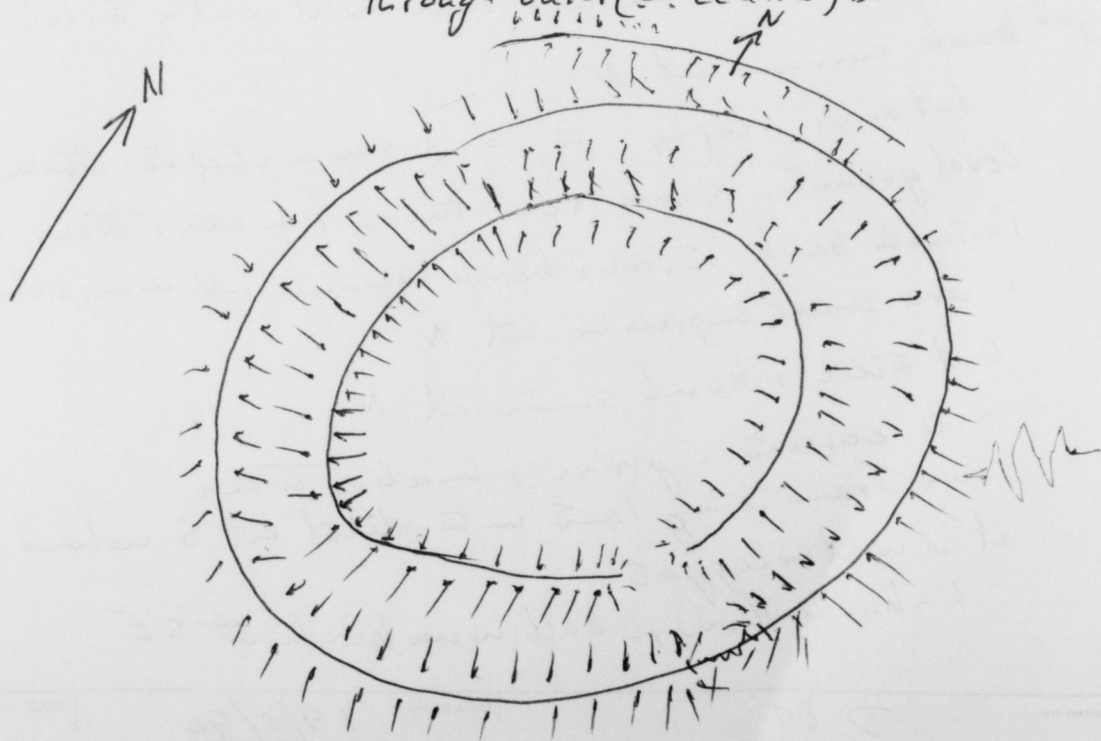
Interior 32.5 m N-S
31.5 m E-W.

Interior Perimeter Bank

1.0 m high internally
2.4 ~~m~~ m high externally (over inner ditch)
3 ~~m~~ m wide

Inner Ditch 5.0 m wide

Centre bank 2.7 m high internally (over inner ditch)
5.0 m wide
2.0 m high externally (over outer ditch)

Outer ditch 4.5 m wide

Outer bank 1.5 m ^{high} internally (over outer ditch)
2.6 m wide
0.5 m high externally.

Entrance at ~~SE~~ ESE: through inner bank - 3 m wide
through outer (i.e. centre) bank - 4 m wide
