SM7/00WN 44.12

BALLYLUCAS

MOUND

ARCHAEOLOGICAL SURVEY OF NORTHERN IRELAND

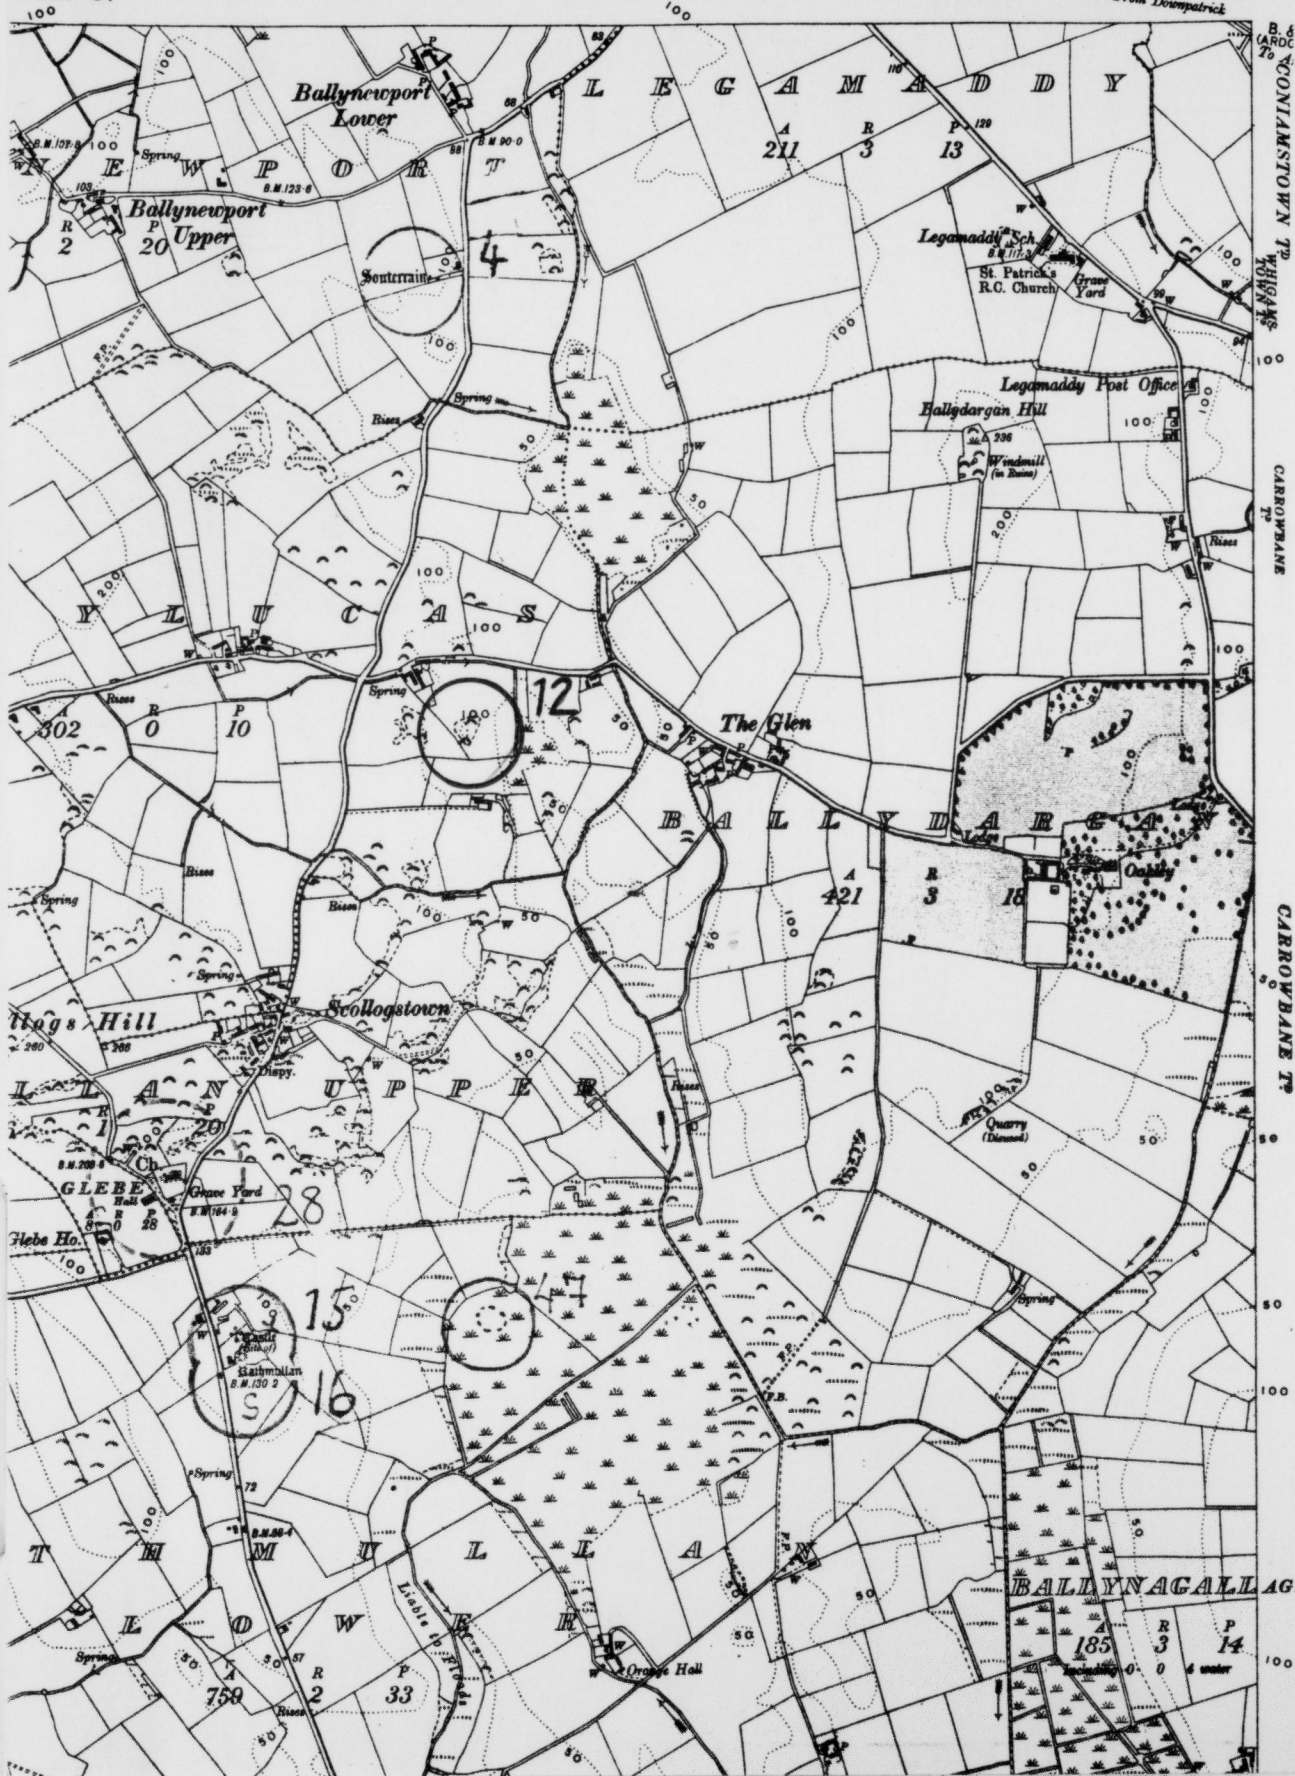
On poor pasture land sloping to the S.E. with several rock outcrops present in neighbouring fields. The site is marked as 'Fort' on the 1st. edition of the OS six-inch map and is shown by a small, undesignated fort convention on the 2nd edition and is absent from later editions. This dramatic mound is a steeply scarped outcrop of natural rock standing 3.5 m. high at the N. and 7.0 m. above the natural slope of the field at the S. Whin and thorn shrubs cling to the sides. A narrow livestock path leads to the oval grassy summit measuring 18.0 m N.-S. by 13.0 m. E.-W.; the uneven surface slopes down to the E. side which is about 0.7 m. below the W. perimeter. A broken perimeter bank 2.0 m wide stands about 0.6 m. at its highest at the N. A steep ditch 2.0 m. wide debouches over the E. side about 1.5 m. below the edge of the summit. The rock face at the N. has been recently quarried.
