Archaeological Monitoring Report

For the proposed development of
Newtownabbey Way Phase 3,
Co. Antrim

Client: WDR & RT Taggart

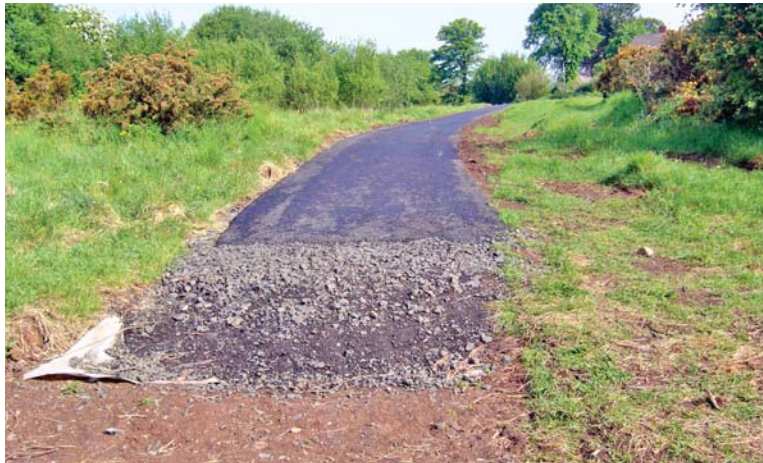
PLATE 1: Section 1: Looking at section of unfinished pathway towards Three Mile Water.

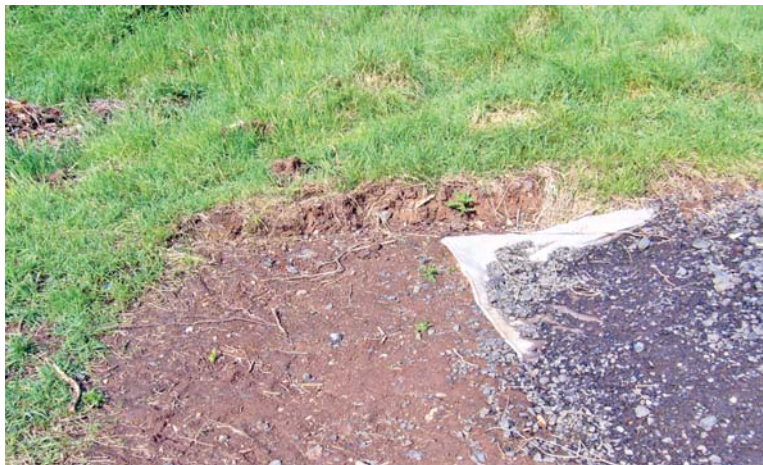
PLATE 2: Section1: Detail of unfinished pathway showing depth of excavation.

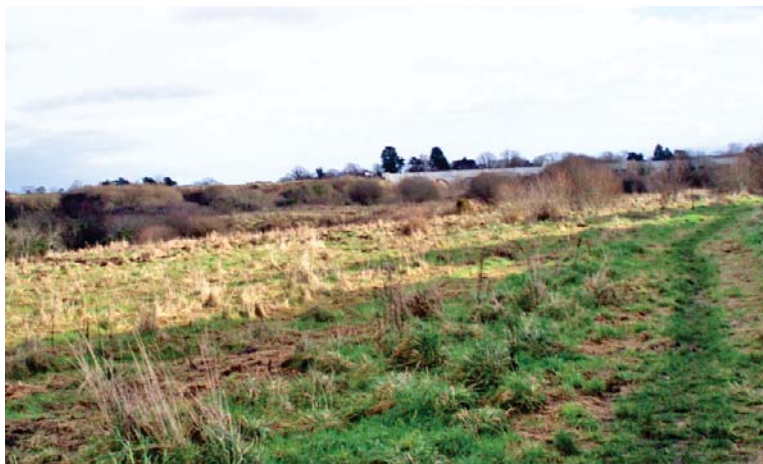
PLATE 3: Section 2: Looking east across area

This section was located towards the southeast of the main pathway on high ground overlooking the Three Mile Water (Plate 3). The area consisted of level marginal ground that has seen disturbance in the form of tree planting by the Woodland Trust (Plates 4-5).

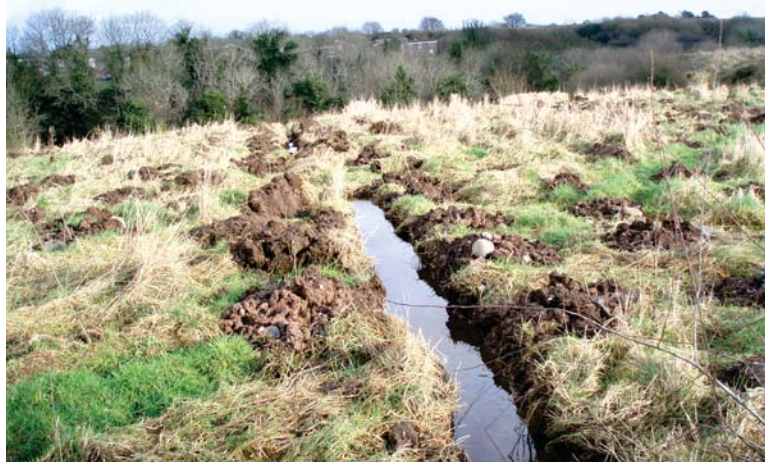
PLATE 4: Section 2: Evidence of trenches and ground disturbance caused by Woodland Trust plantings schemes.

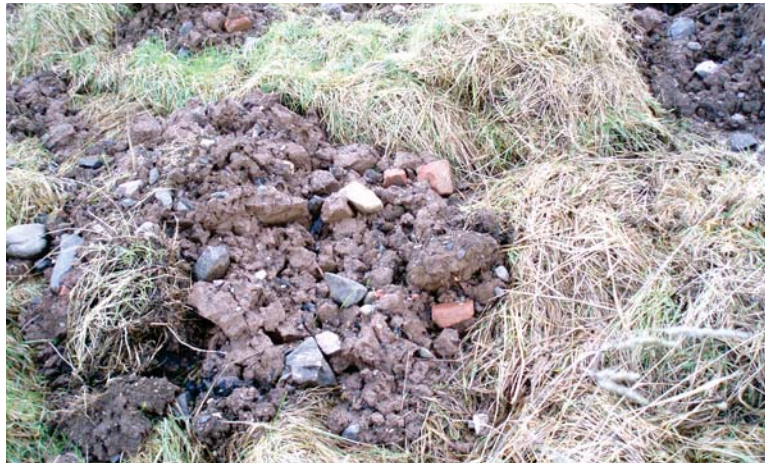
PLATE 5: Section 2: Sapling planting with evidence of modern fill material in spoil.

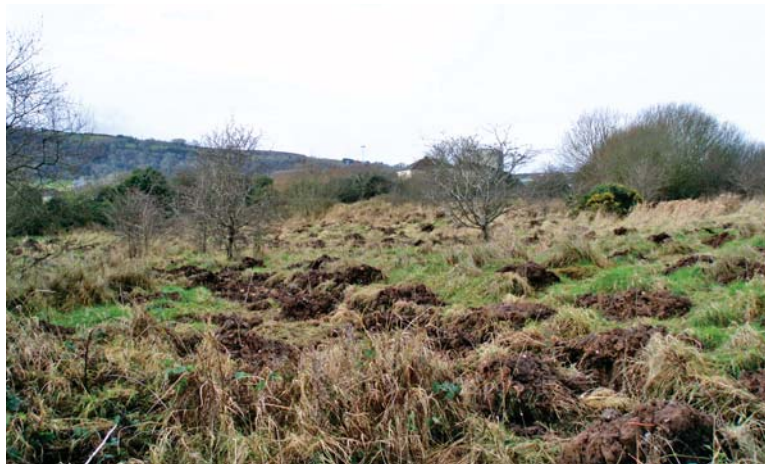
This rubble has been imported from elsewhere and may have been associated with the Whiteabbey Bleachworks (IHR 07316:000:00) that was originally located to the south of the area. This site has since been demolished and replaced with housing. The pathway was under construction at the time of the time of monitoring, though it had not yet entered the area where the possible souterrain and rath (ANT 057:012) may be located (Plate 6).

PLATE 6: Section 2: Looking south from section towards possible location of souterrain and rath (ANT 057:012).

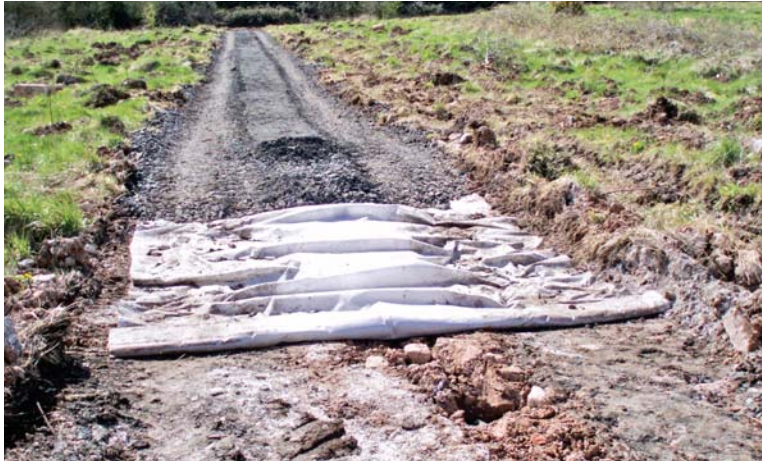
PLATE 7: Section 2: section of partially constructed footpath.

Examination of the pathway already partially extant clearly showed the method of construction (Plate 7). Topsoil was stripped to the required depth and a layer of terram laid on the exposed surface. This terram was then covered with a layer of hardcore. The hardcore was awaiting a finishing layer of tarmac.

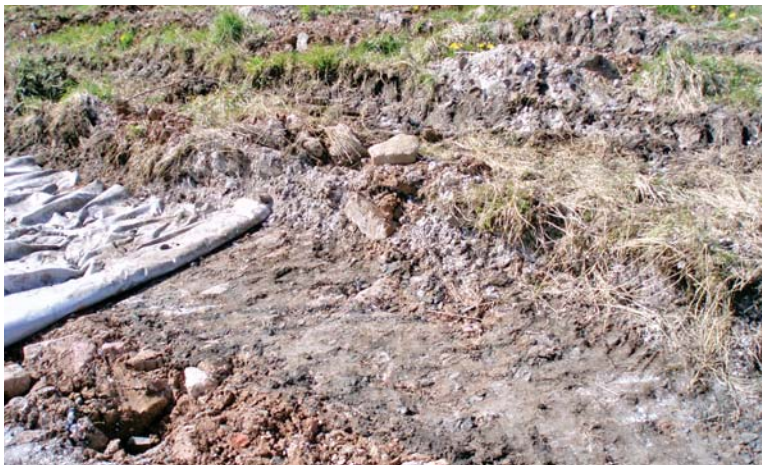
PLATE 8: Section 2: detail of partially constructed footpath showing depth of excavation into imported hardcore surface.

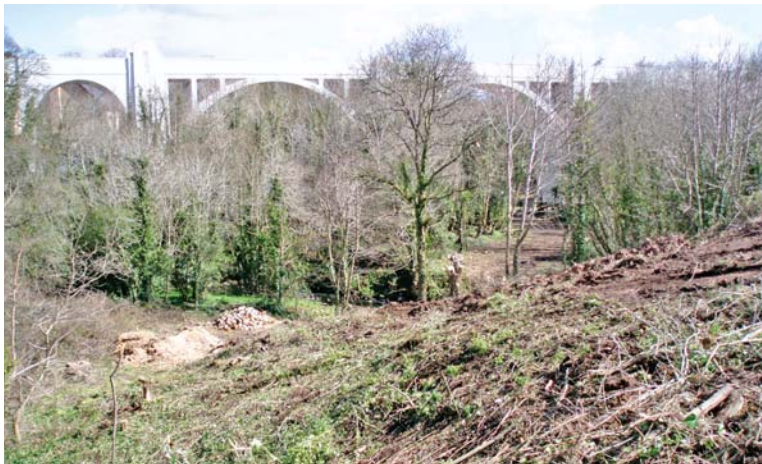
PLATE 9: Section 2: looking downslope across area into valley of the Three Mile Water.

the area, it was surmised that topsoil stripping associated with the main pathway would not impact upon any subsurface archaeological features, should they exist. However, the proposed route of the pathway ran southeast from this area down a steep slope into the valley of the Three Mile Water (Plate 9). Large scale groundworks were required in this area in order to create an appropriate gradient for the path.

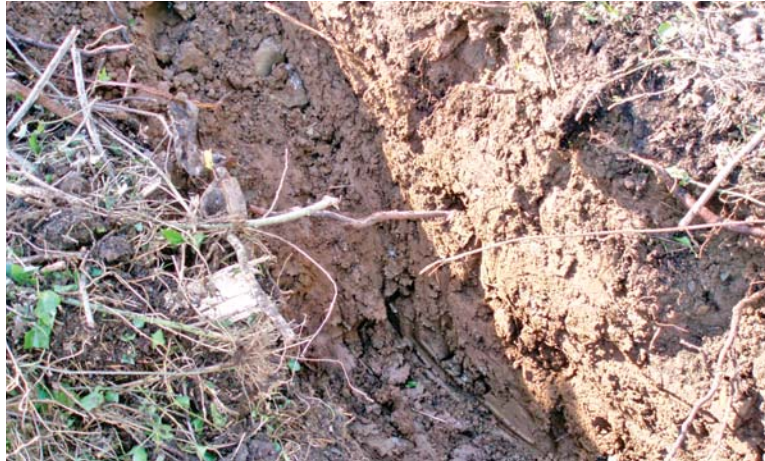
PLATE 10: Test Pit 1: Detail of test pit showing glacial sub-soil consisting of clean, pink boulder clay overlain by a layer of light brown clay mixed with small stones.

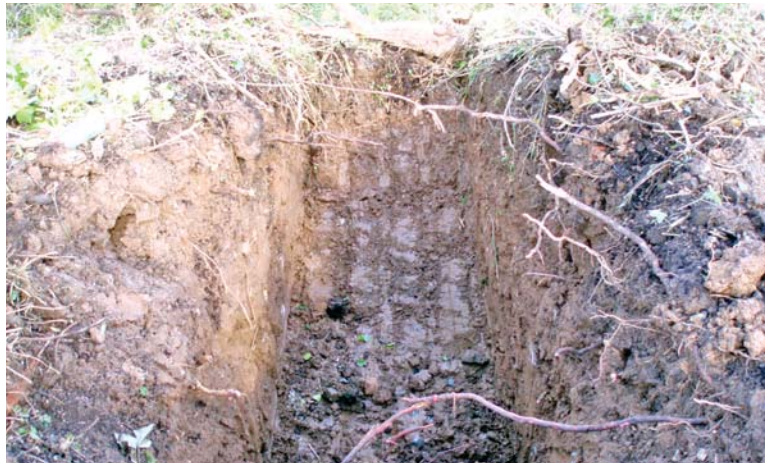
PLATE 11: Test Pit 1: Looking downslope across test pit showing clean, pink boulder clay at base.

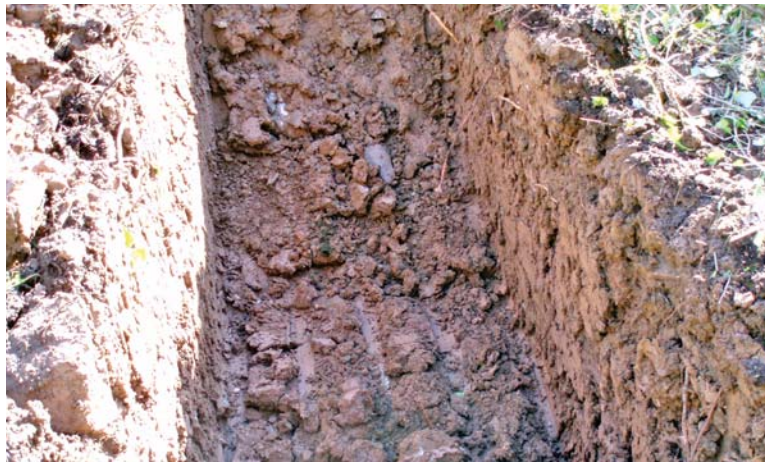
Testing was also carried out on level ground at the base of the hill (Plate 12). Glacial subsoil consisted of clean, pink boulder clay which was exposed at a depth of approximately 0.6m. This was overlain with a layer of light brown clay which contained modern artefacts such as a plastic bag in its upper layers. This layer was overlain with a thin layer of sod/vegetation. No evidence of possible archaeological features was observed.

PLATE 12: Test Pit 2: Looking southeast across test pit. Note glacial sub-soil consisting of clean, pink boulder clay overlain by a layer of light brown clay mixed with small stones.

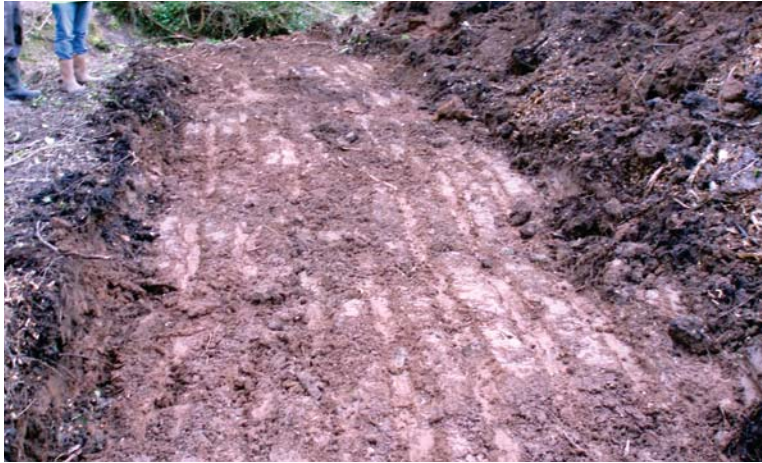
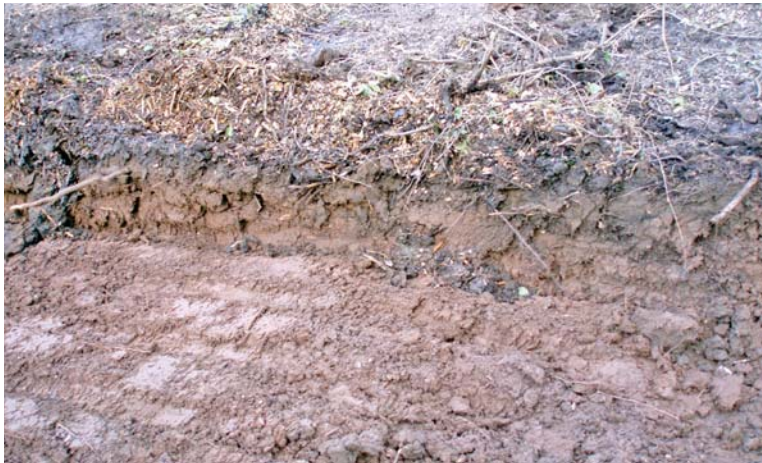
This depth was exceeded for the purpose of testing with approximately 0.4m of topsoil removed expose glacial subsoil (Plates 13 & 14). No evidence of possible archaeological features was noted within this area.

PLATE 13: Section 3: looking southeast along section between base of hill and the Three Mile Water .

PLATE 14: Section 3: detail of depth of excavation showing glacial subsoil approximately 0.4m below current ground level.

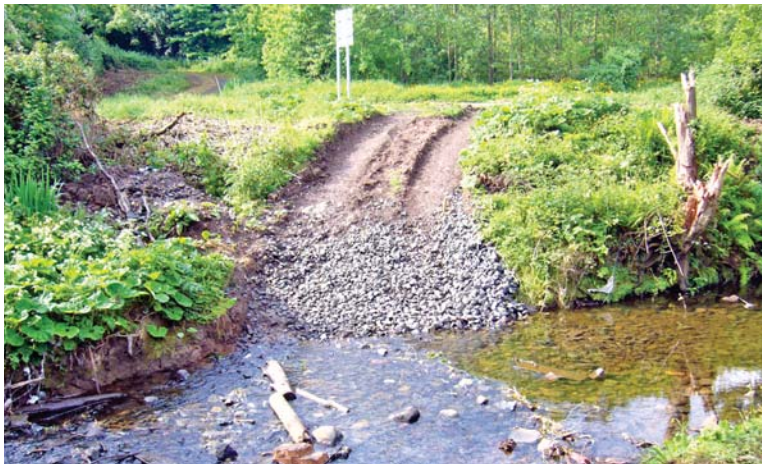
PLATE 15: Bridge Footings 1: bridge footing on south bank of the Three Mile Water.

These are located towards the western end of the development and carry the pathway south across the Three Mile Water from the area of Cashel Drive (Plates 15 & 16).

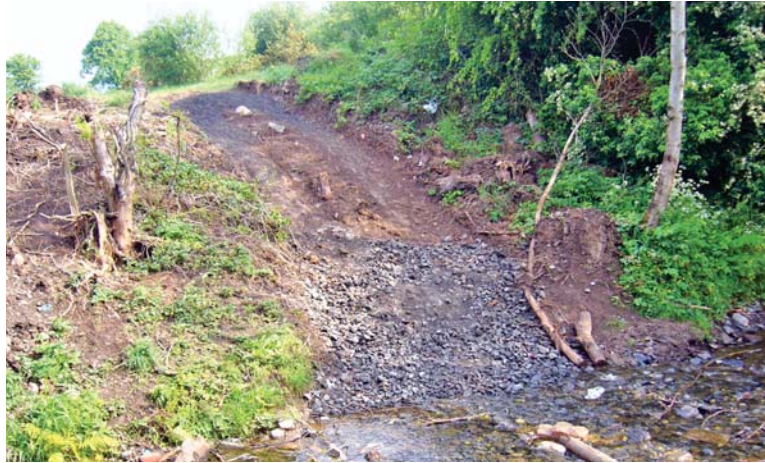
PLATE 16: Bridge Footings 1: bridge footing on north bank of the Three Mile Water.

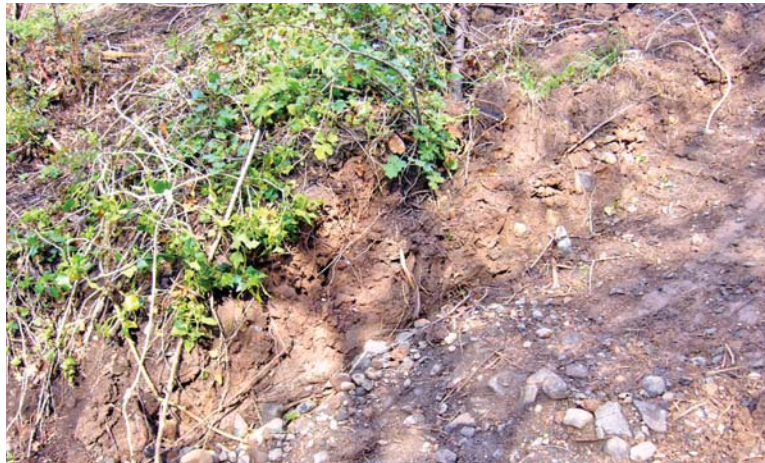
The groundworks within this area consisted of topsoil stripping as a continuation of the main pathway. Examination of exposed section faces suggested that topsoil within these areas appeared to have been stripped to a depth of 0.4m exposing glacial sub-soil consisting of pink/grey boulder clay (Plate 17). No archaeological features were noted.

PLATE 17: Bridge Footings 1: detail of depth of excavation of bridge footing

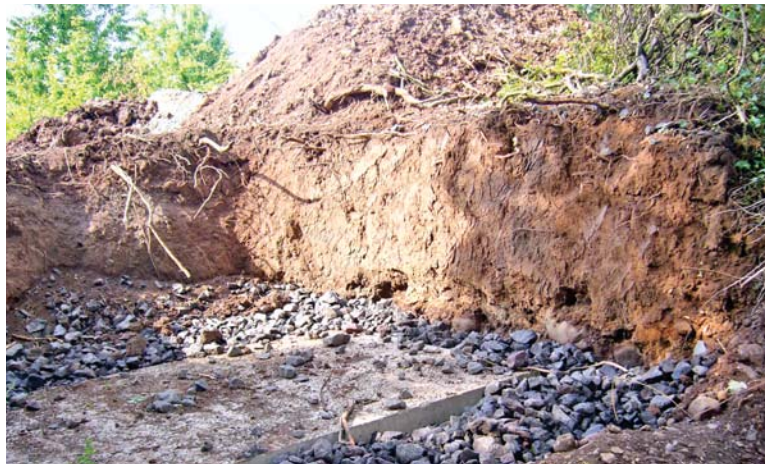
PLATE 18: Bridge Footings 2: bridge footings on south bank of the Three Mile Water. Note clean orange boulder clay comprising section face.

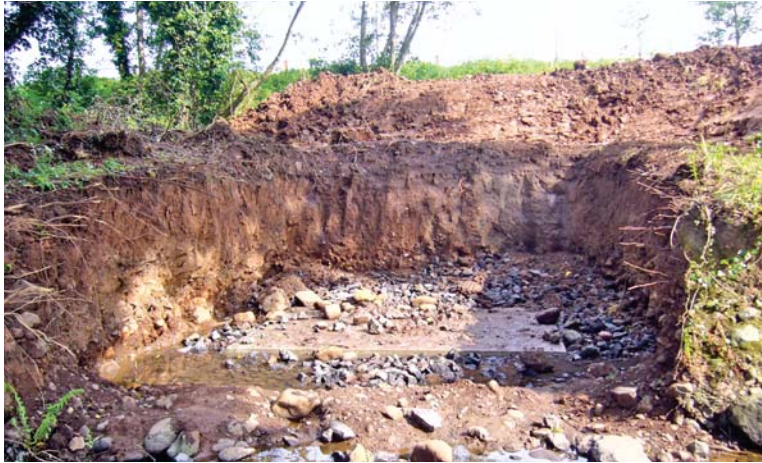
PLATE 19: Bridge Footings 2: bridge footings on north bank of the Three Mile Water.

These bridge footings carry the off-shoot running south from Devenish Drive across the Three Mile Water. The bridge footings consisted of rectangular sections dug out of both river banks (Plates 18&19).

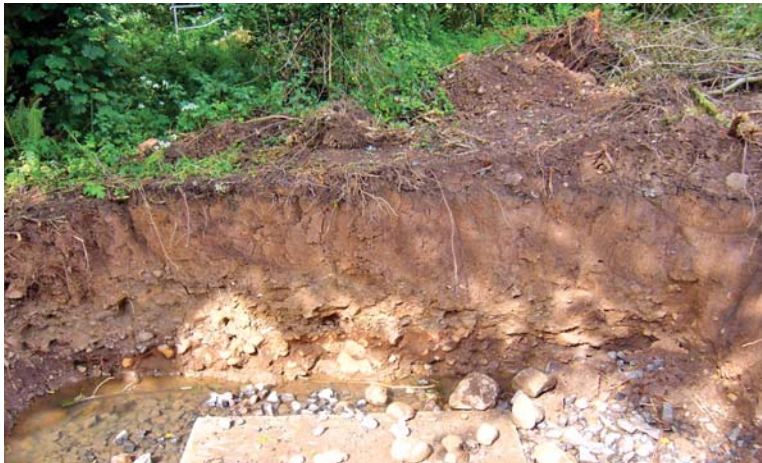
PLATE 20: Bridge Footings 2: detail of east facing section of bridge footing on north bank of the Three Mile Water.

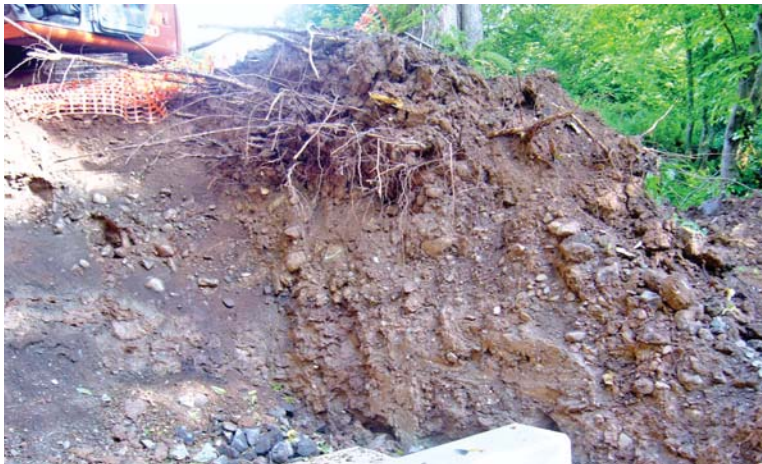
PLATE 21: Bridge Footings 3: detail of bridge footings on northwest bank of Three Mile Water.

These bridge footings were located towards the eastern end of the proposed development immediately adjacent to Section 3 of the main pathway. Again, two rectangular sections had been dug into the river bank to a depth of approximately 1.5m with concrete bases laid and the surrounding excavated ground in-filled with gravel (Plates 21 & 22).

The excavated faces within both footings showed no evidence of possible archaeological features. The footing on the western bank of the river consisted of pink basal boulder clay overlain with a layer of light brown clay which in turn was overlain with a thin layer of sod (Plate 21).

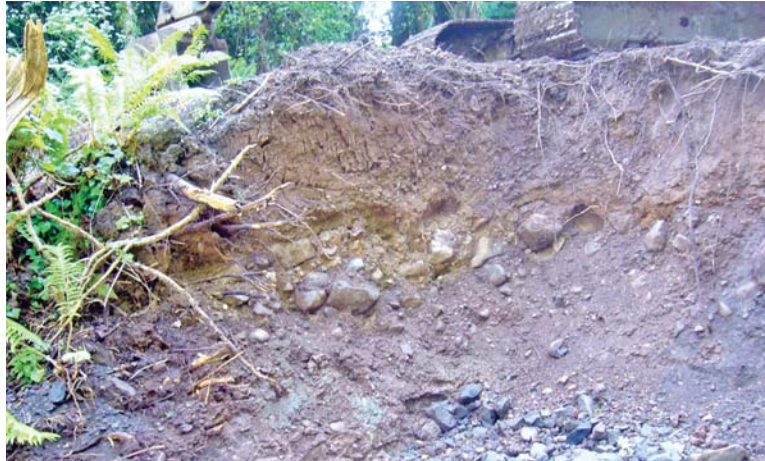
PLATE 22: Bridge Footings 3: detail of bridge footings on southeast bank of Three Mile Water.

The excavated footing on the east bank of the river revealed different material (Plate 22). The lower layer of this section consisted of pink/grey boulder clay overlain with a naturally occurring layer of gravel/stone which in turn was overlain with a layer of soil under the sod.

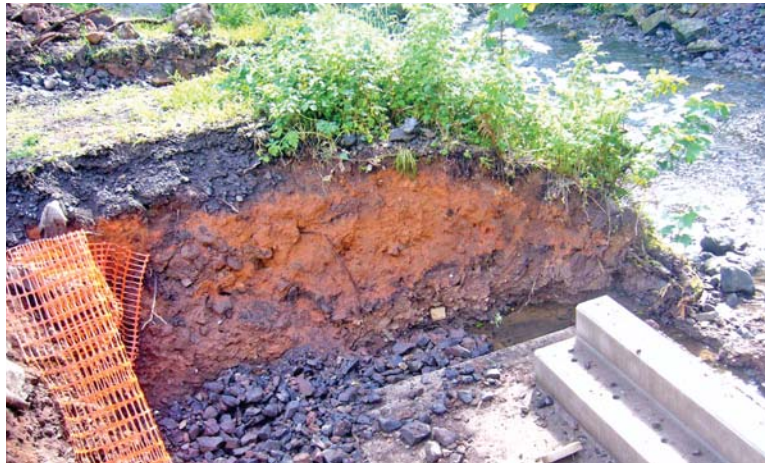
PLATE 23: Bridge Footings 4: the southwest facing section of bridge footing on north bank of Three Mile Water.

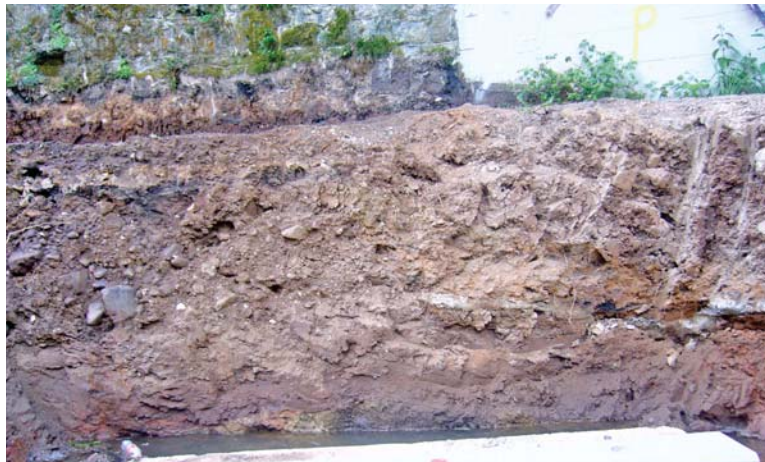
The footing on the south side of the river was located immediately adjacent to the railway viaduct (IHR 01339:289:00). Faces of the footing on the southern side of the river also showed signs of disturbance (Plate 24). The section faces consisted of a mix of light brown clays and stone which were sealed with a layer of concrete. This material appeared to be redeposited and was probably associated with disturbance caused by the construction of the viaduct.

PLATE 24: Bridge Footings 4: bridge footing on south bank of Three Mile Water. Note disturbed nature of ground.
